Resetting EcoSystem Ballasts and Drivers with Lunatone USB 30 mA

Procedure for Clearing EcoSystem Addresses

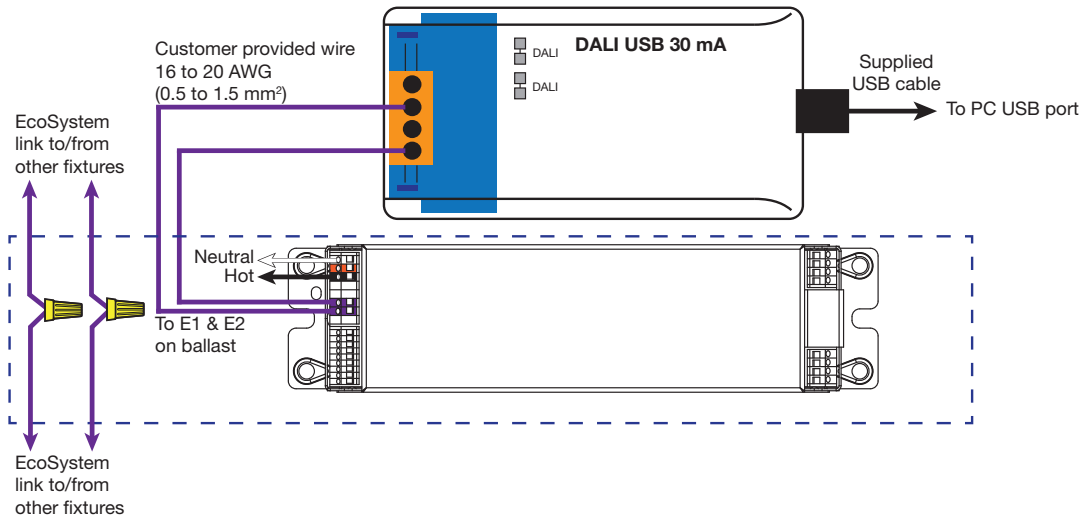
3. Connect the PC to the interface and the interface to the fixture.
 - Turn off power to the fixture.
 - Connect the DALI USB 30 mA interface to the PC via the provided USB cable.
 - Disconnect E1/E2 (EcoSystem bus) from fixture and cap each wire individually; keep the hot/neutral/ground connection in place.
 - Using a length of cable long enough to reach from the Windows PC to the fixture, connect the DA+/DA- from the Lunatone DALI USB 30 mA devices to E1/E2 of the ballast or driver in the fixture; polarity does not matter. See wiring diagram:

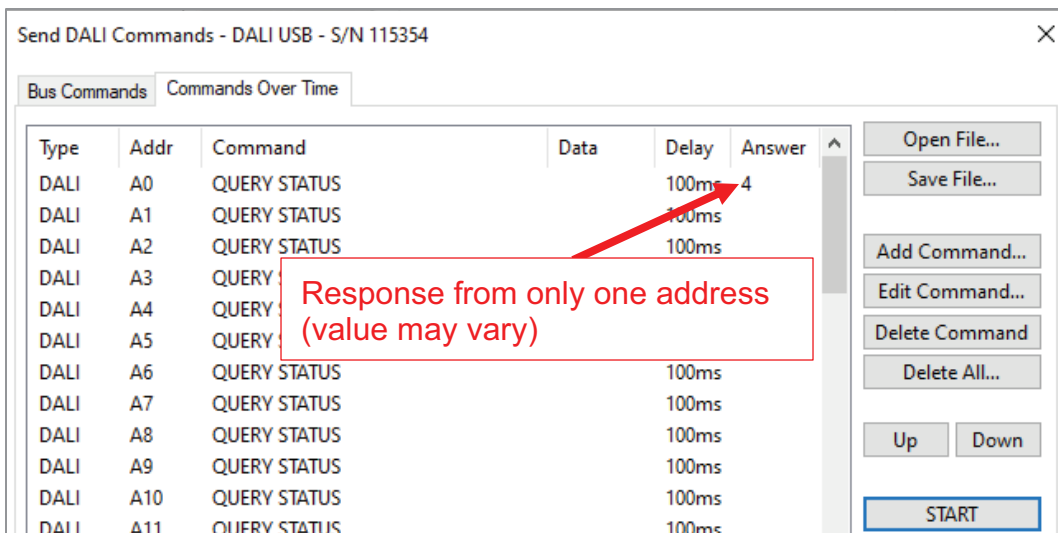
- Wait for script to execute (START button will be reenabled when finished).
- Confirm that only one address (row) provides a reply in the Answer column; you may need to scroll down. The value shown in the “Addr” column represents ONE LESS than the EcoSystem link address (for example, “A0” represents the EcoSystem Link address 1). The value appearing in the Answer column may vary. If “ERR” appears, check wiring (Step 3) and retry Step 4.

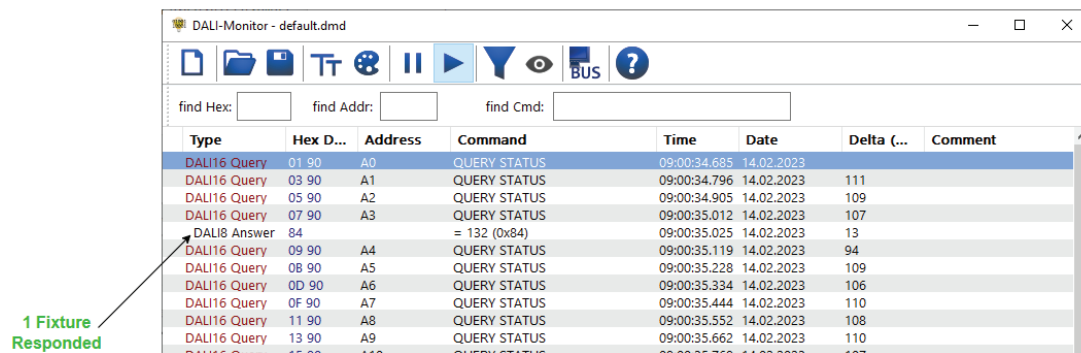
2. When sending commands via the DALI-Cockpit software, you can verify that commands were sent and properly received and acknowledged (if expected). For example, when running the “1-QueryShortAddressesOnBus” with an “Answer”. Before the “2-ClearShortAddressOnBus” commands are sent, you should only receive an “Answer” from one fixture, as shown below:

The screenshot shows the DALI-Monitor software window with a log of commands and responses. A green arrow points to a 'DALI8 Answer' entry with the comment '1 Fixture Responded'. The log table has columns: Type, Hex D..., Address, Command, Time, Date, Delta (...), and Comment.

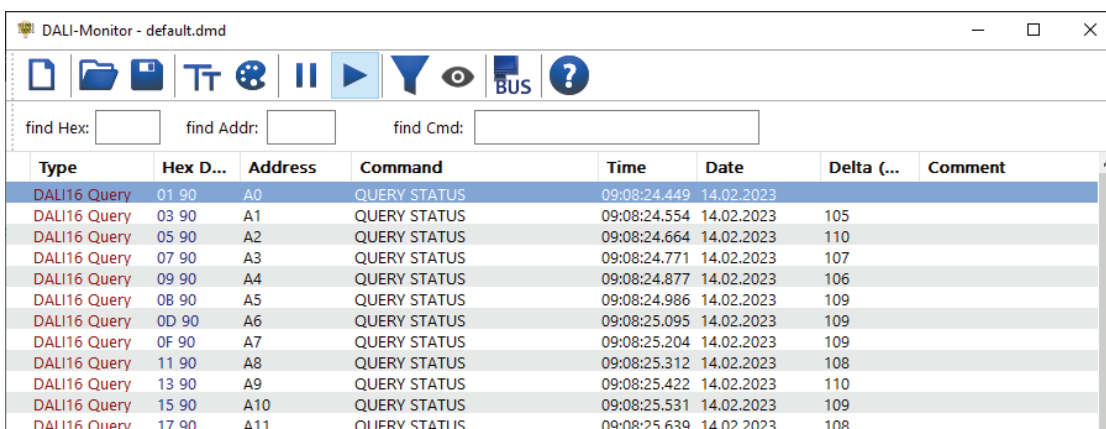
3. Once an address is cleared, you should not get an “Answer” from any fixtures, as shown here:

The screenshot shows the DALI-Monitor software window with a log of commands and responses. No 'Answer' entries are present. The log table has columns: Type, Hex D..., Address, Command, Time, Date, Delta (...), and Comment.
